**REPORT NUMBER: 301-MGA-2008-006**

**SAFETY COMPLIANCE TESTING FOR FMVSS 301R  
FUEL SYSTEM INTEGRITY – REAR IMPACT**

**GENERAL MOTORS CORPORATION  
2008 TAHOE HYBRID  
NHTSA NUMBER: C80111**

**PREPARED BY:  
MGA RESEARCH CORPORATION  
5000 WARREN ROAD  
BURLINGTON, WI 53105**

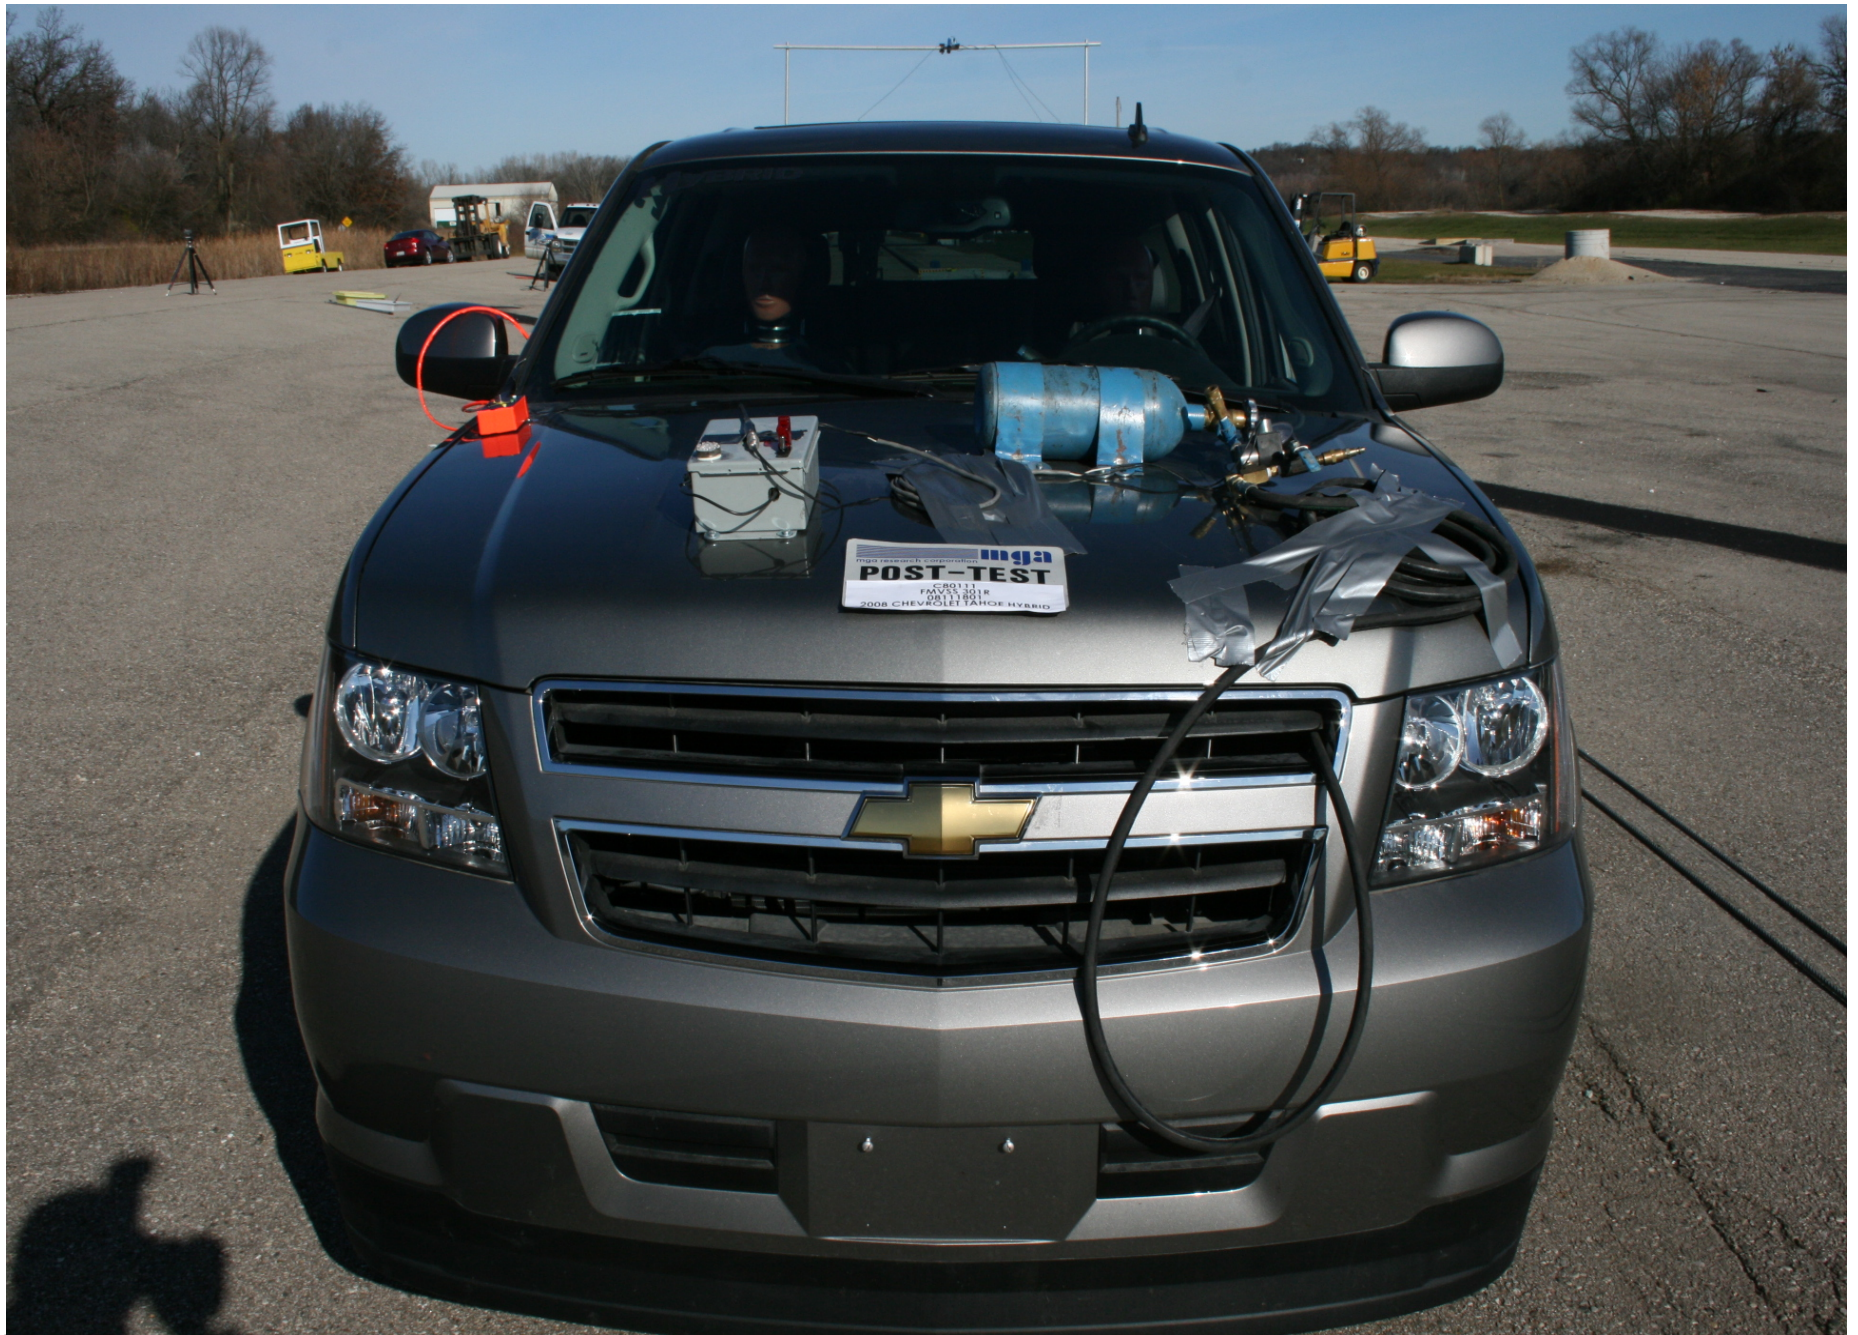
Post-Test Front View of Vehicle

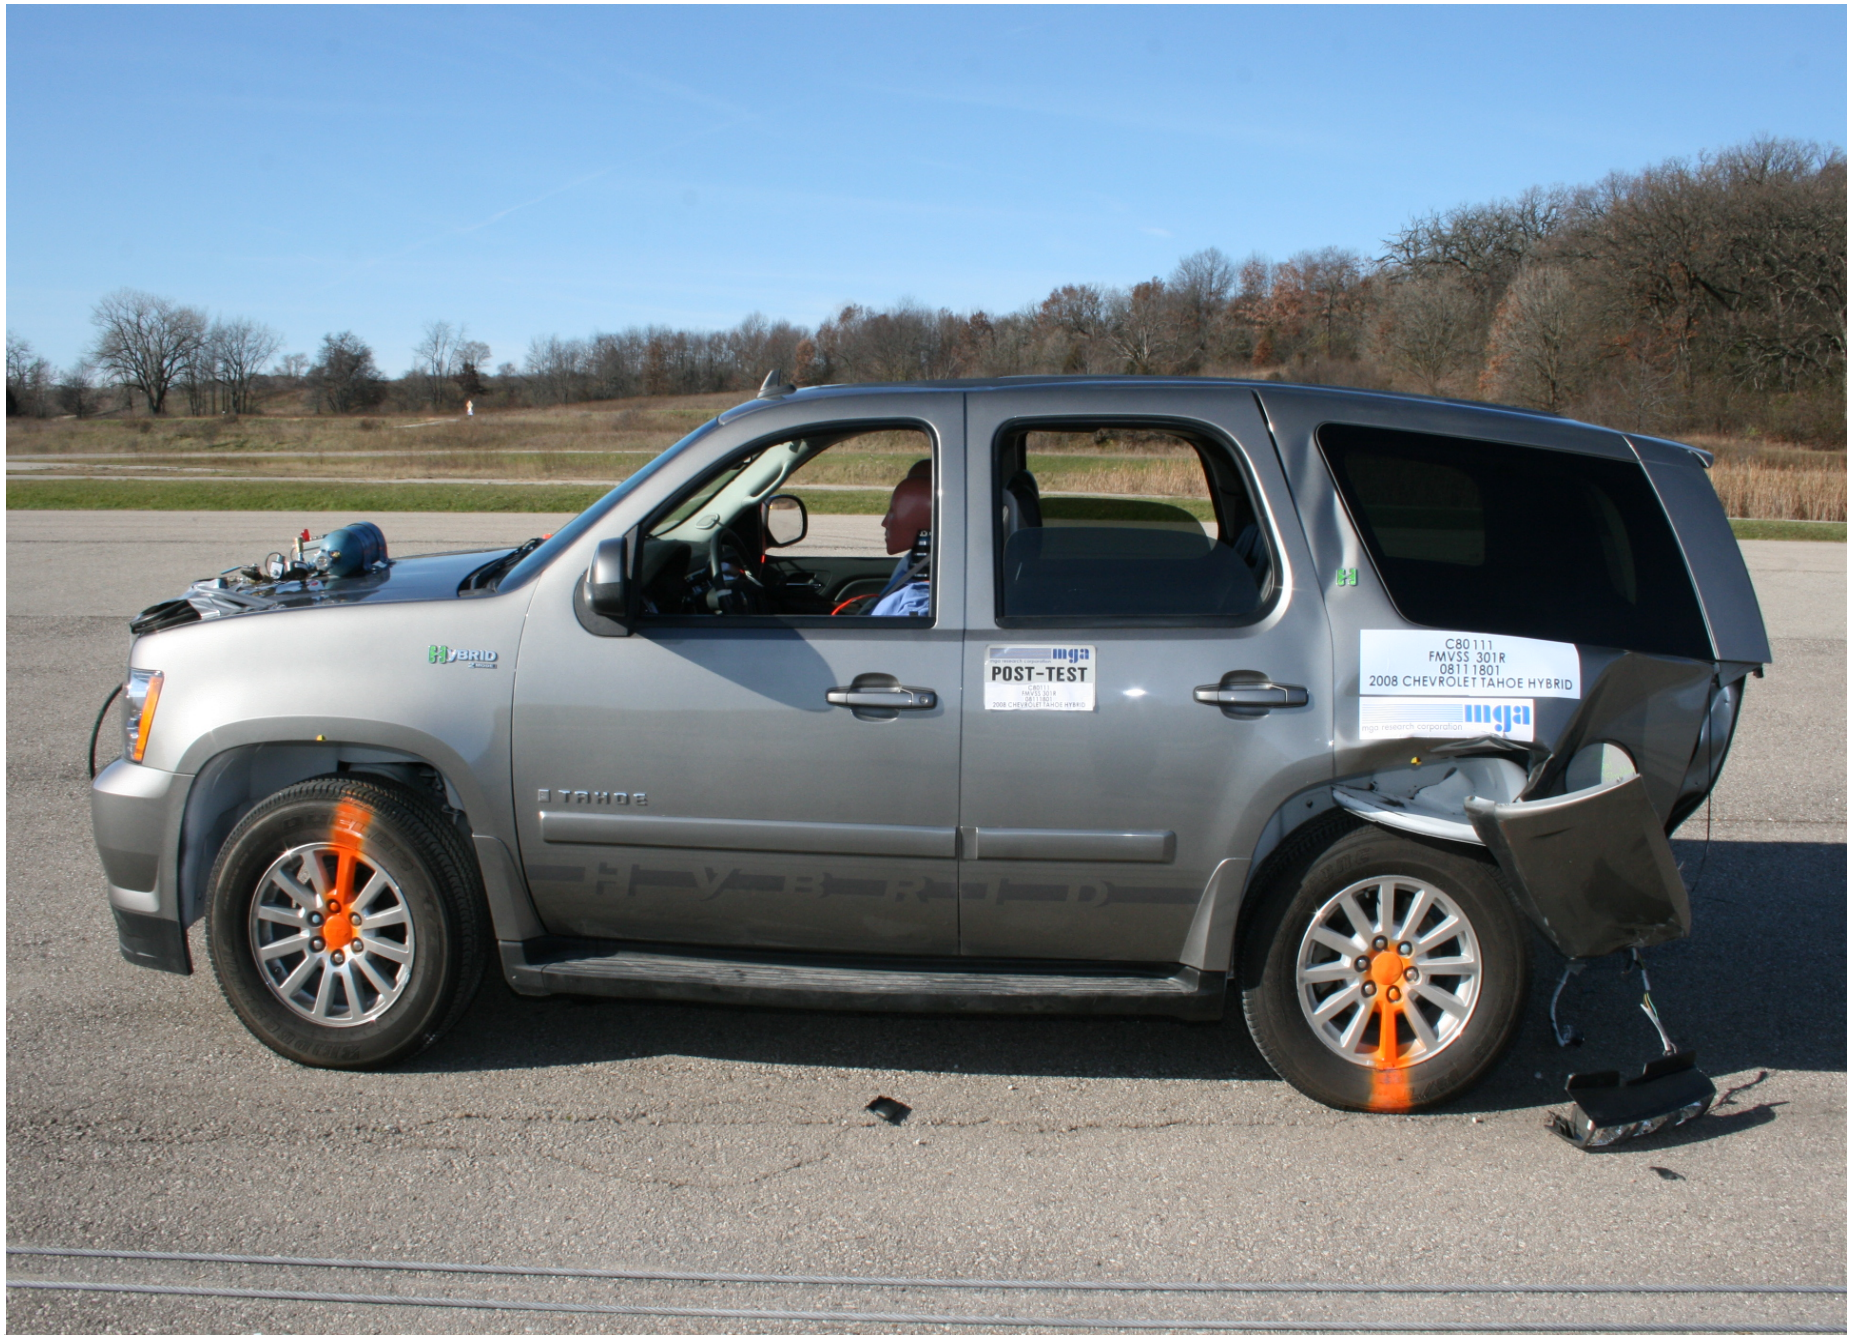
Post-Test Left Side View of Test Vehicle

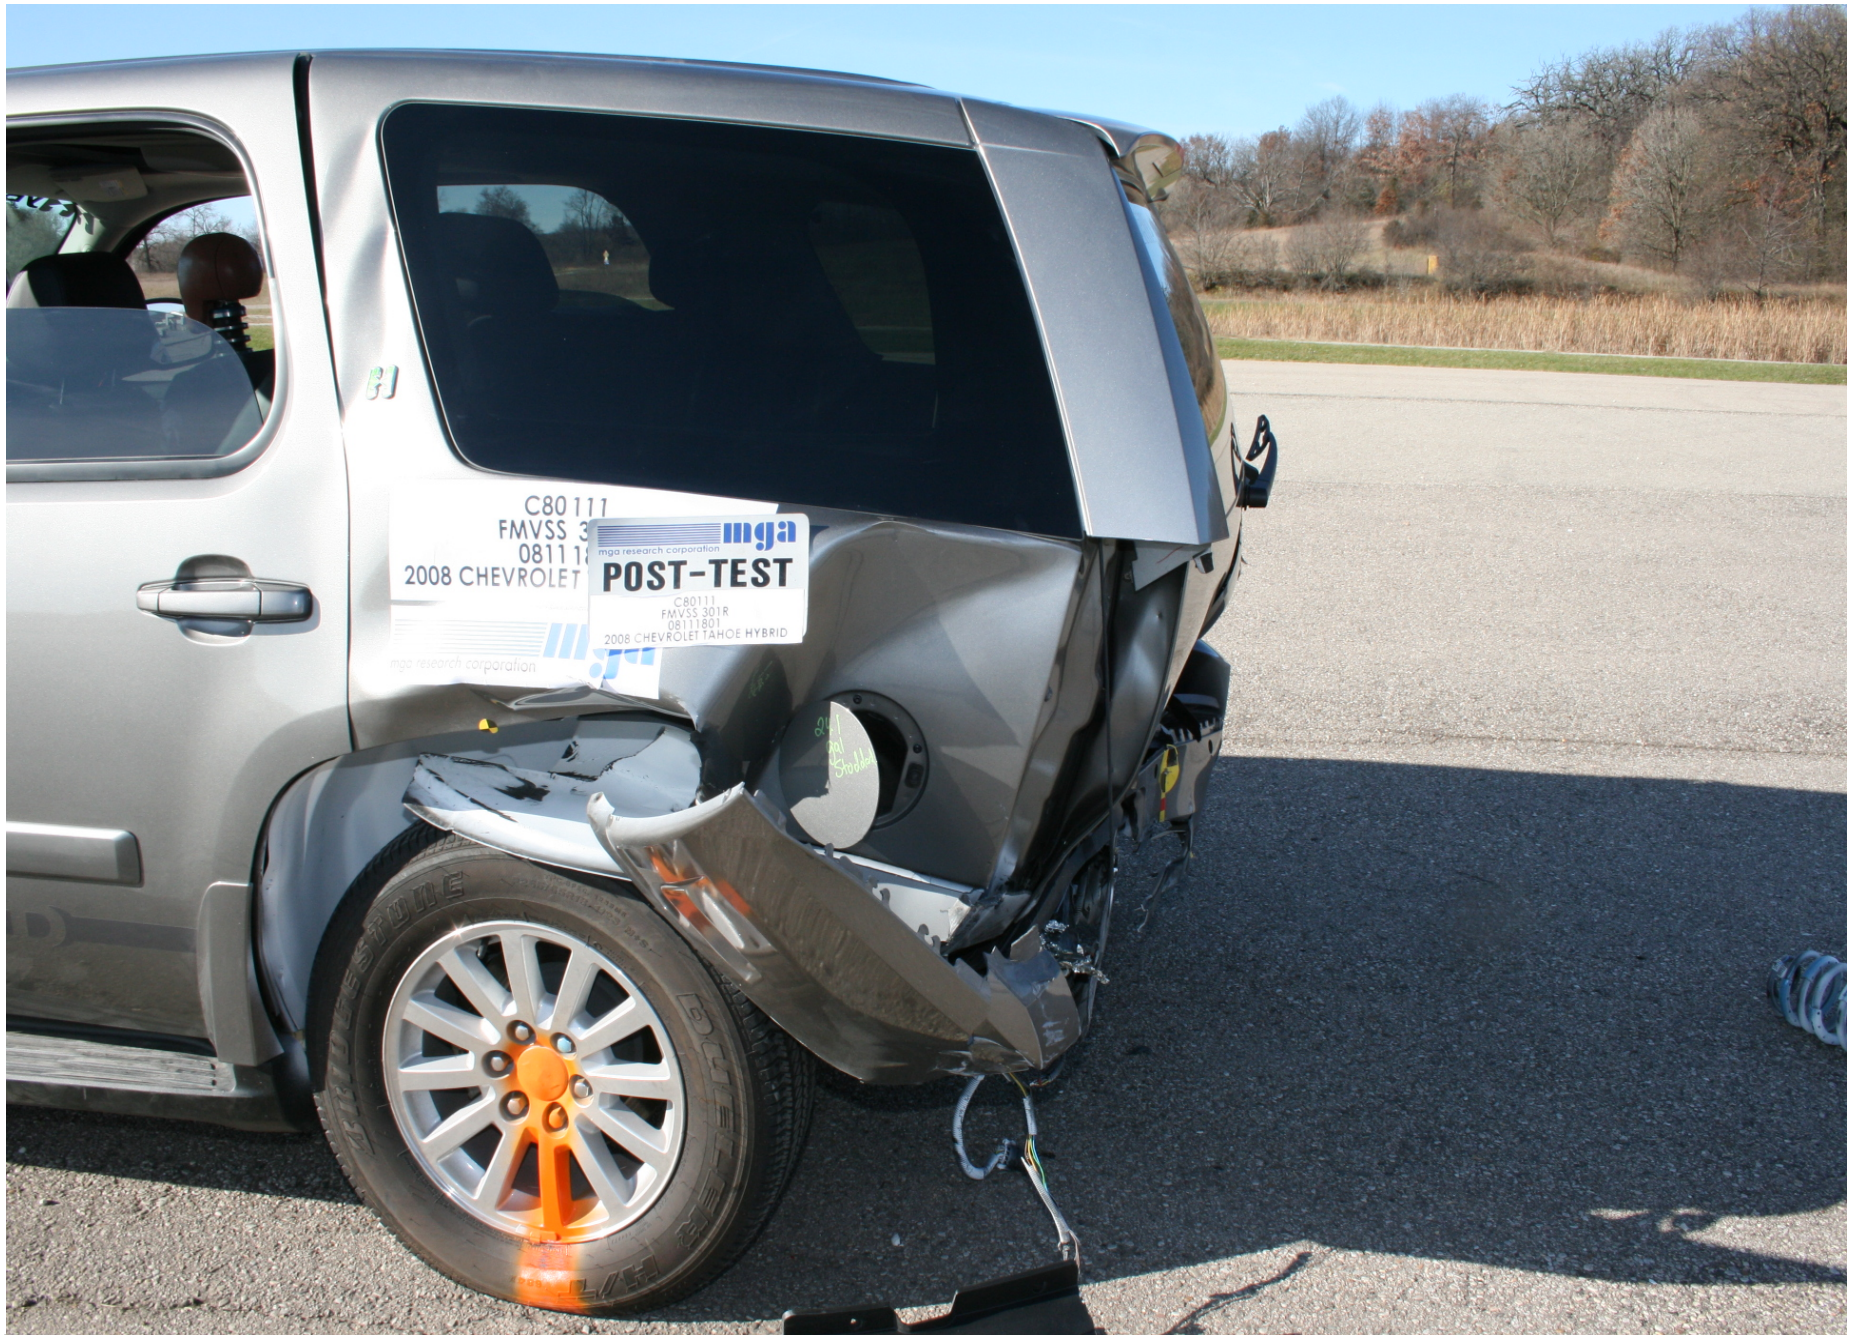
Post-Test Left Rear Closeup View of Vehicle

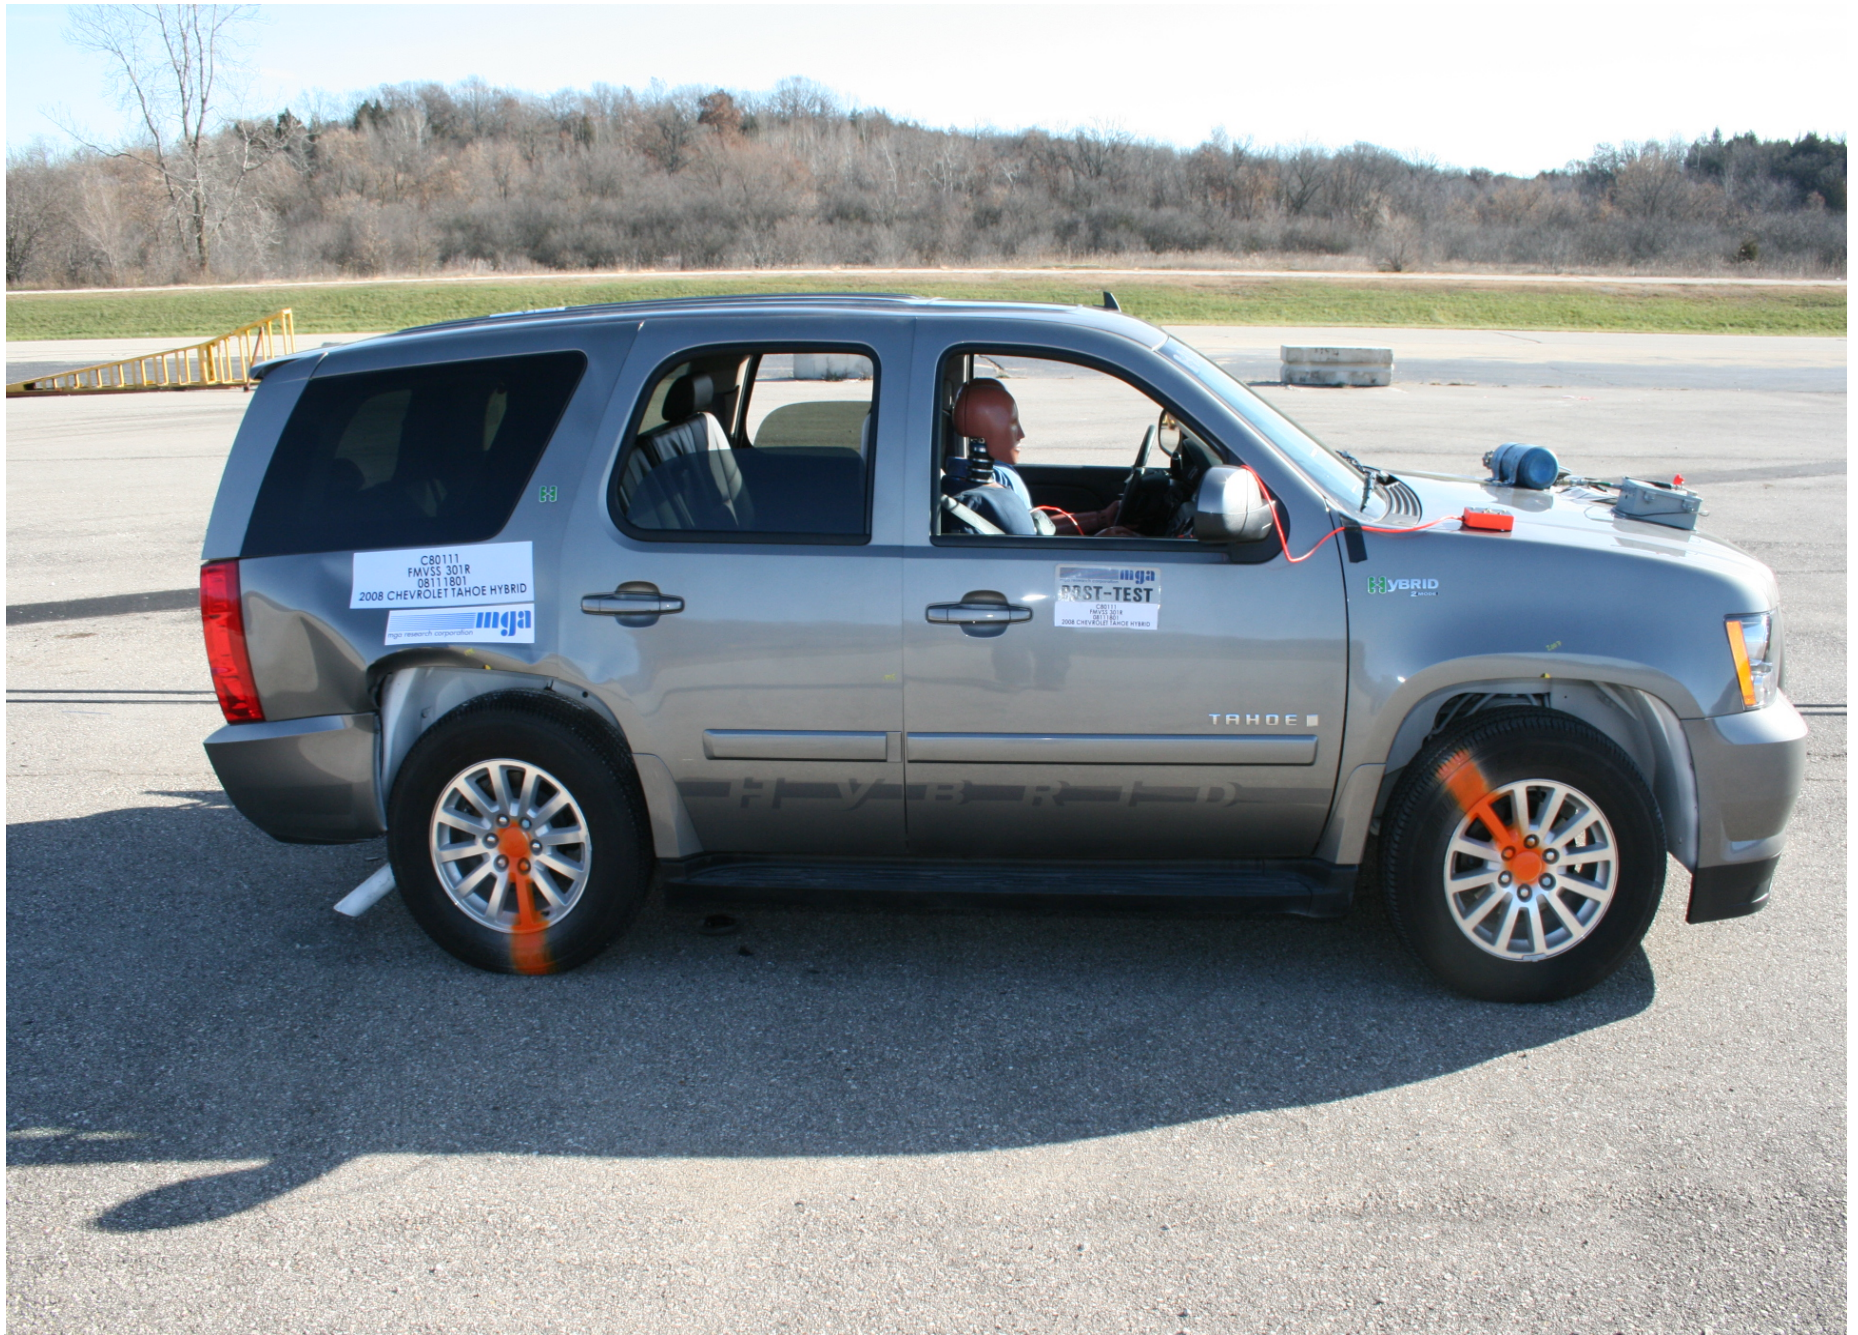
Post-Test Right Side View of Vehicle

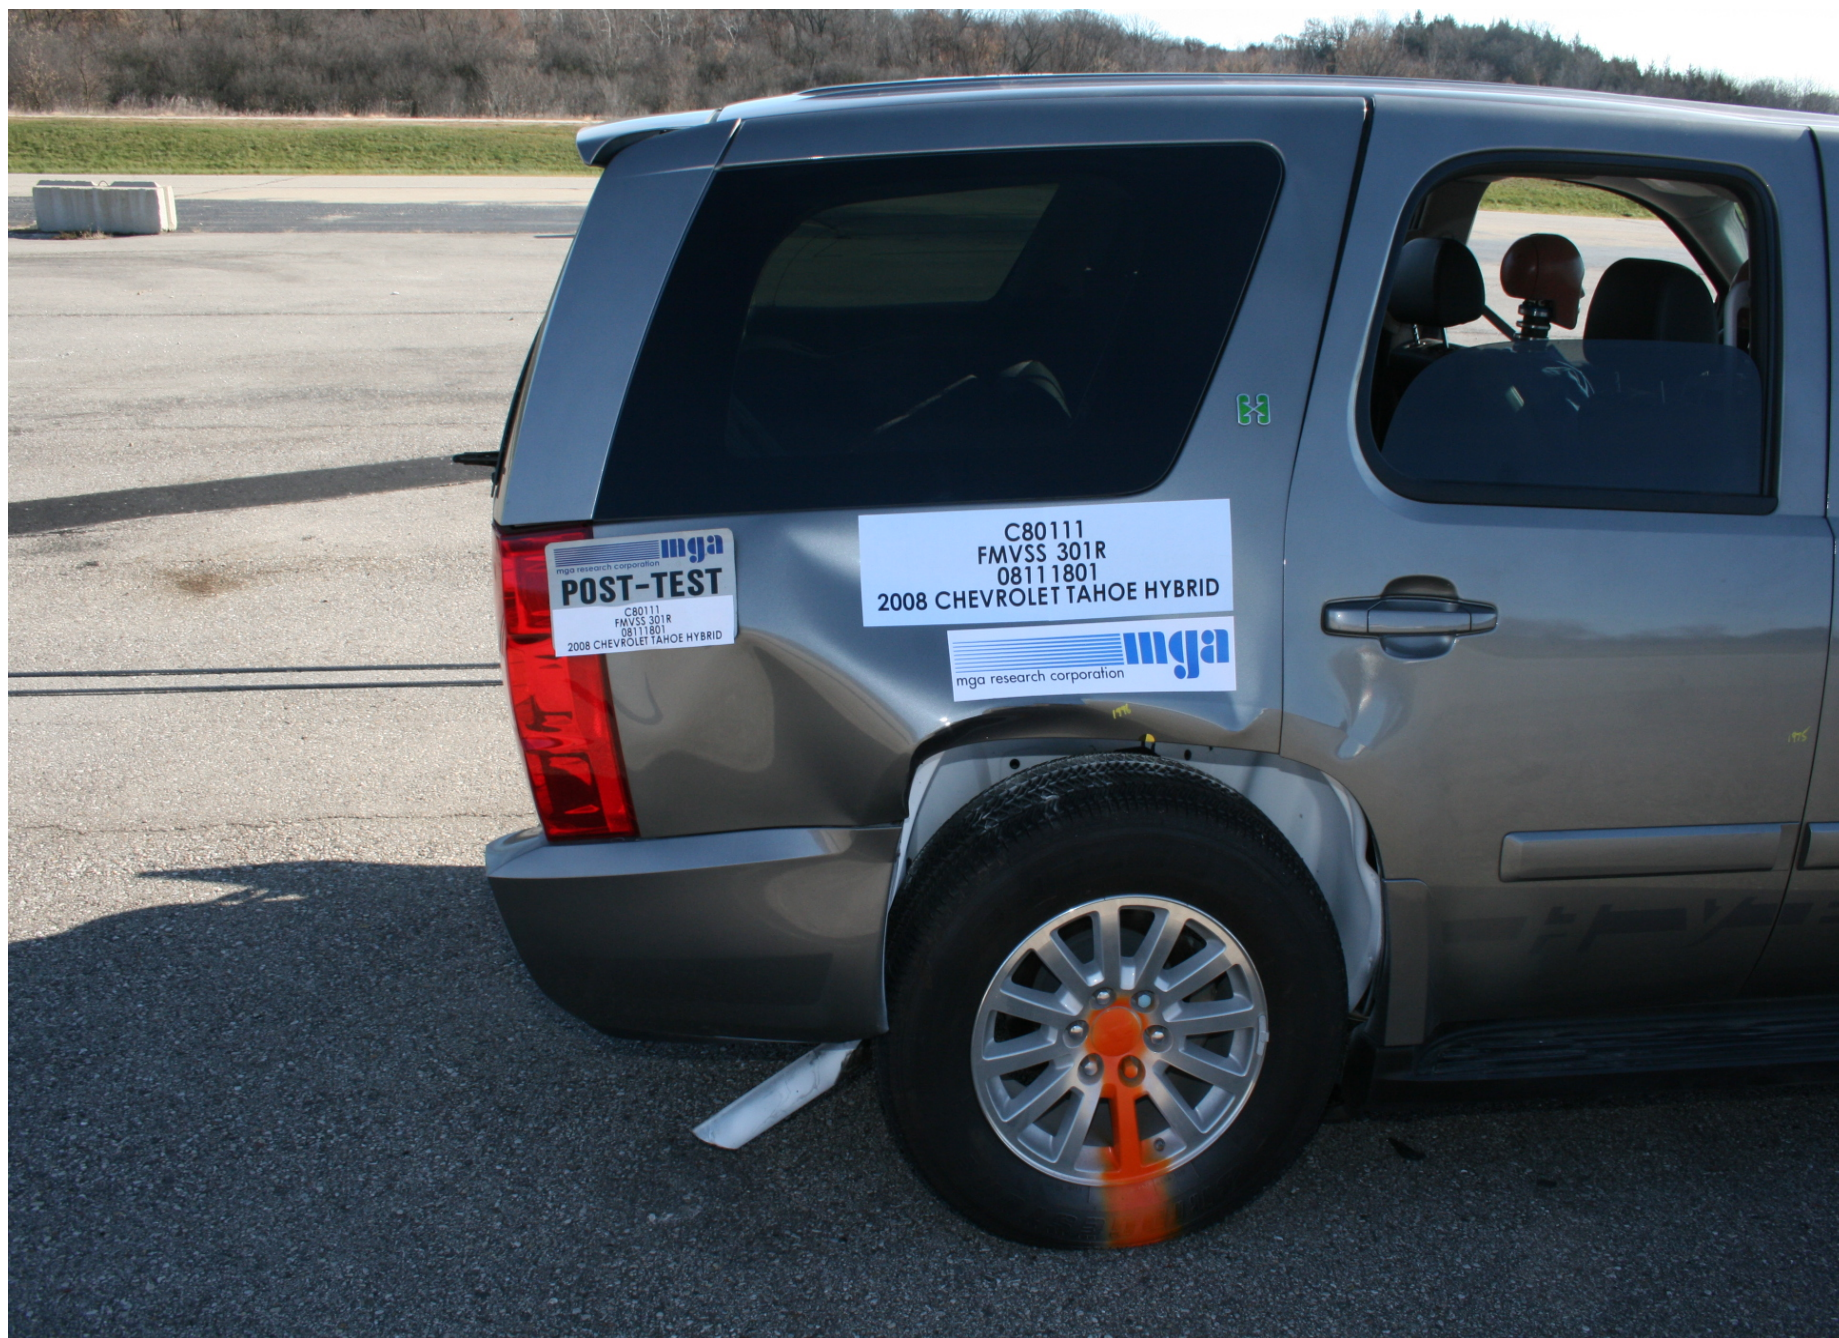
Post-Test Right Rear Closeup View of Vehicle

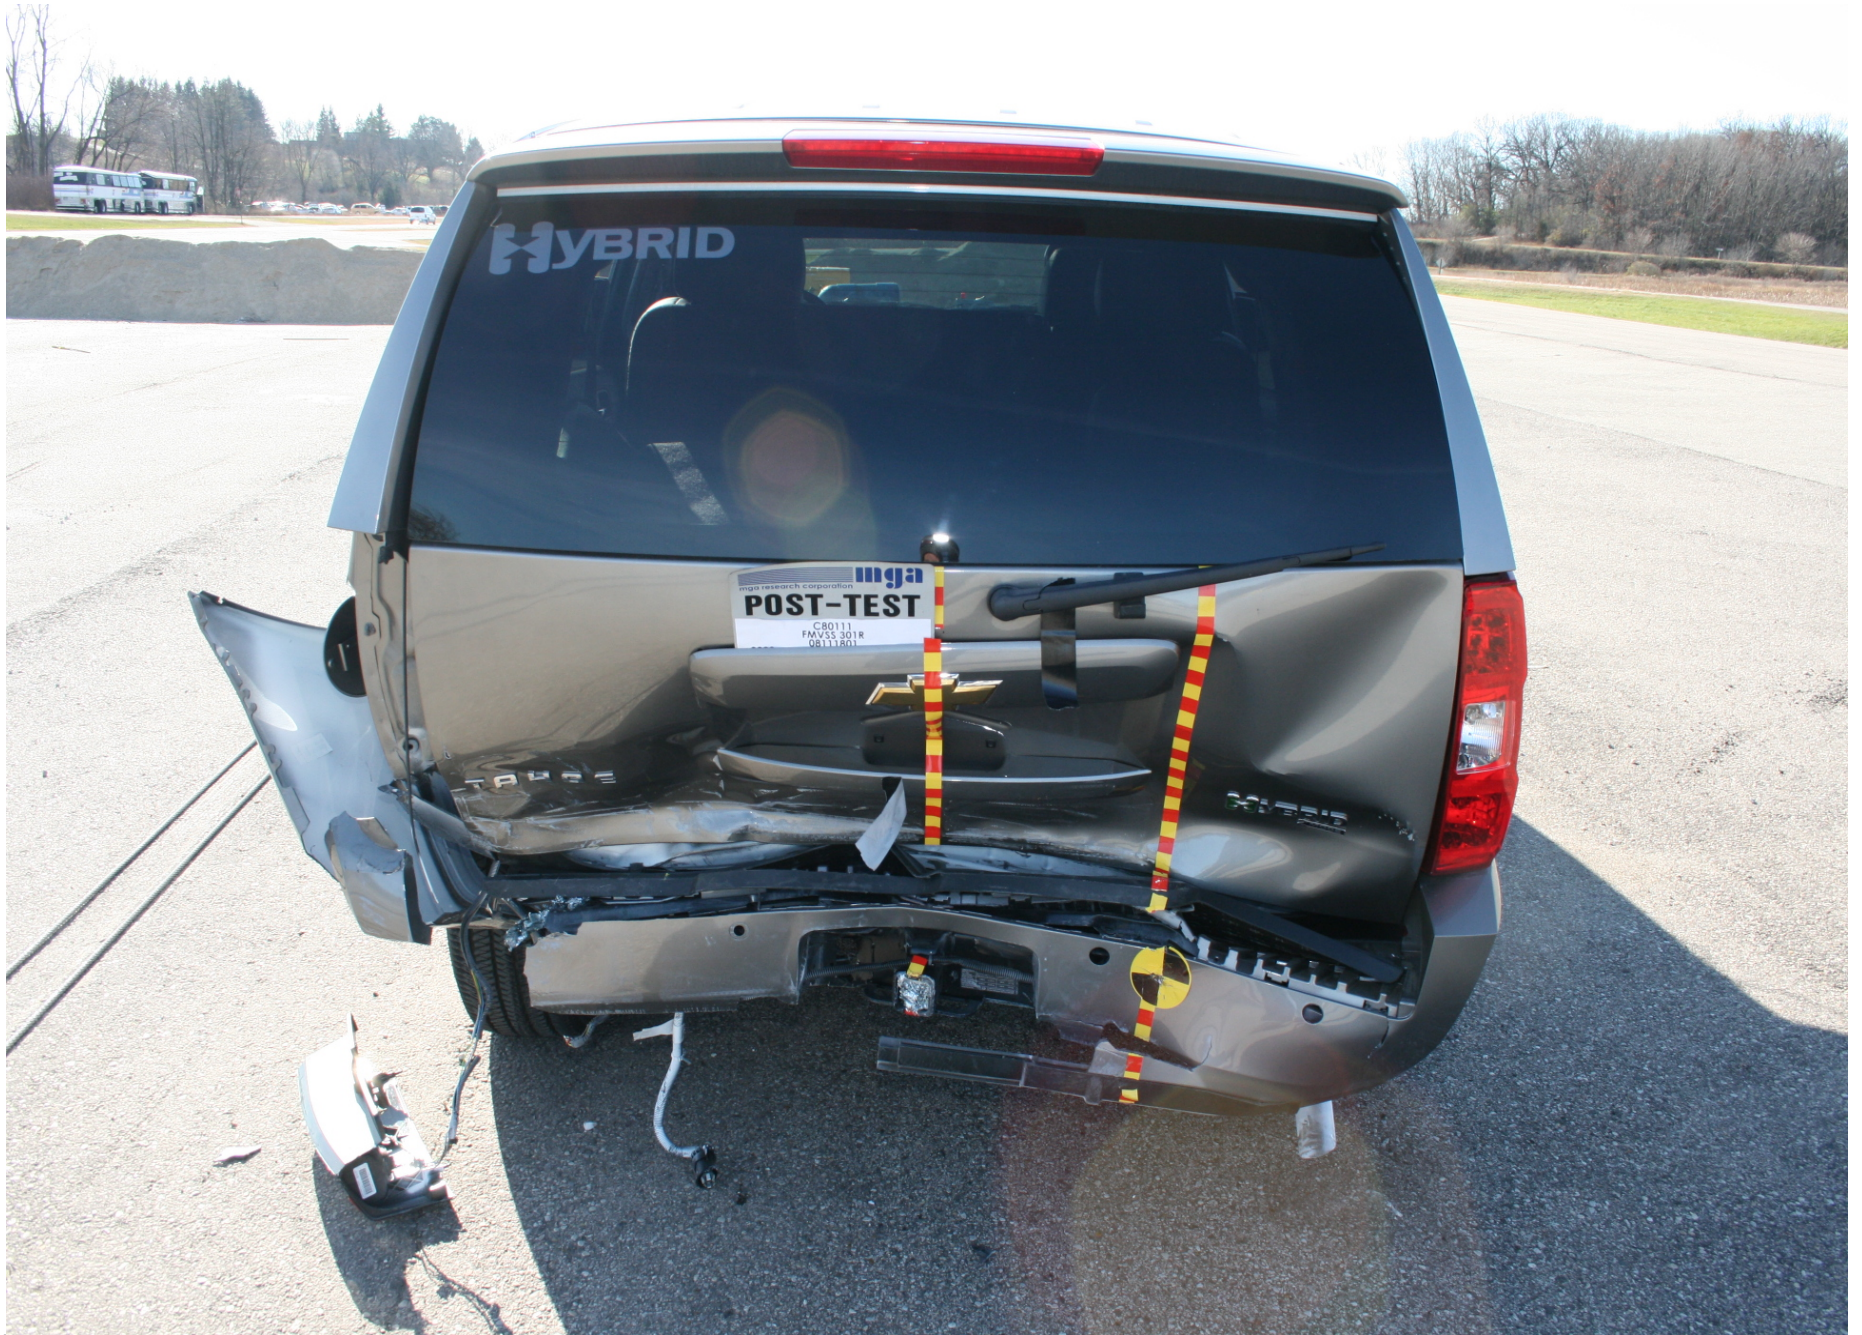
Post-Test Rear View of Vehicle

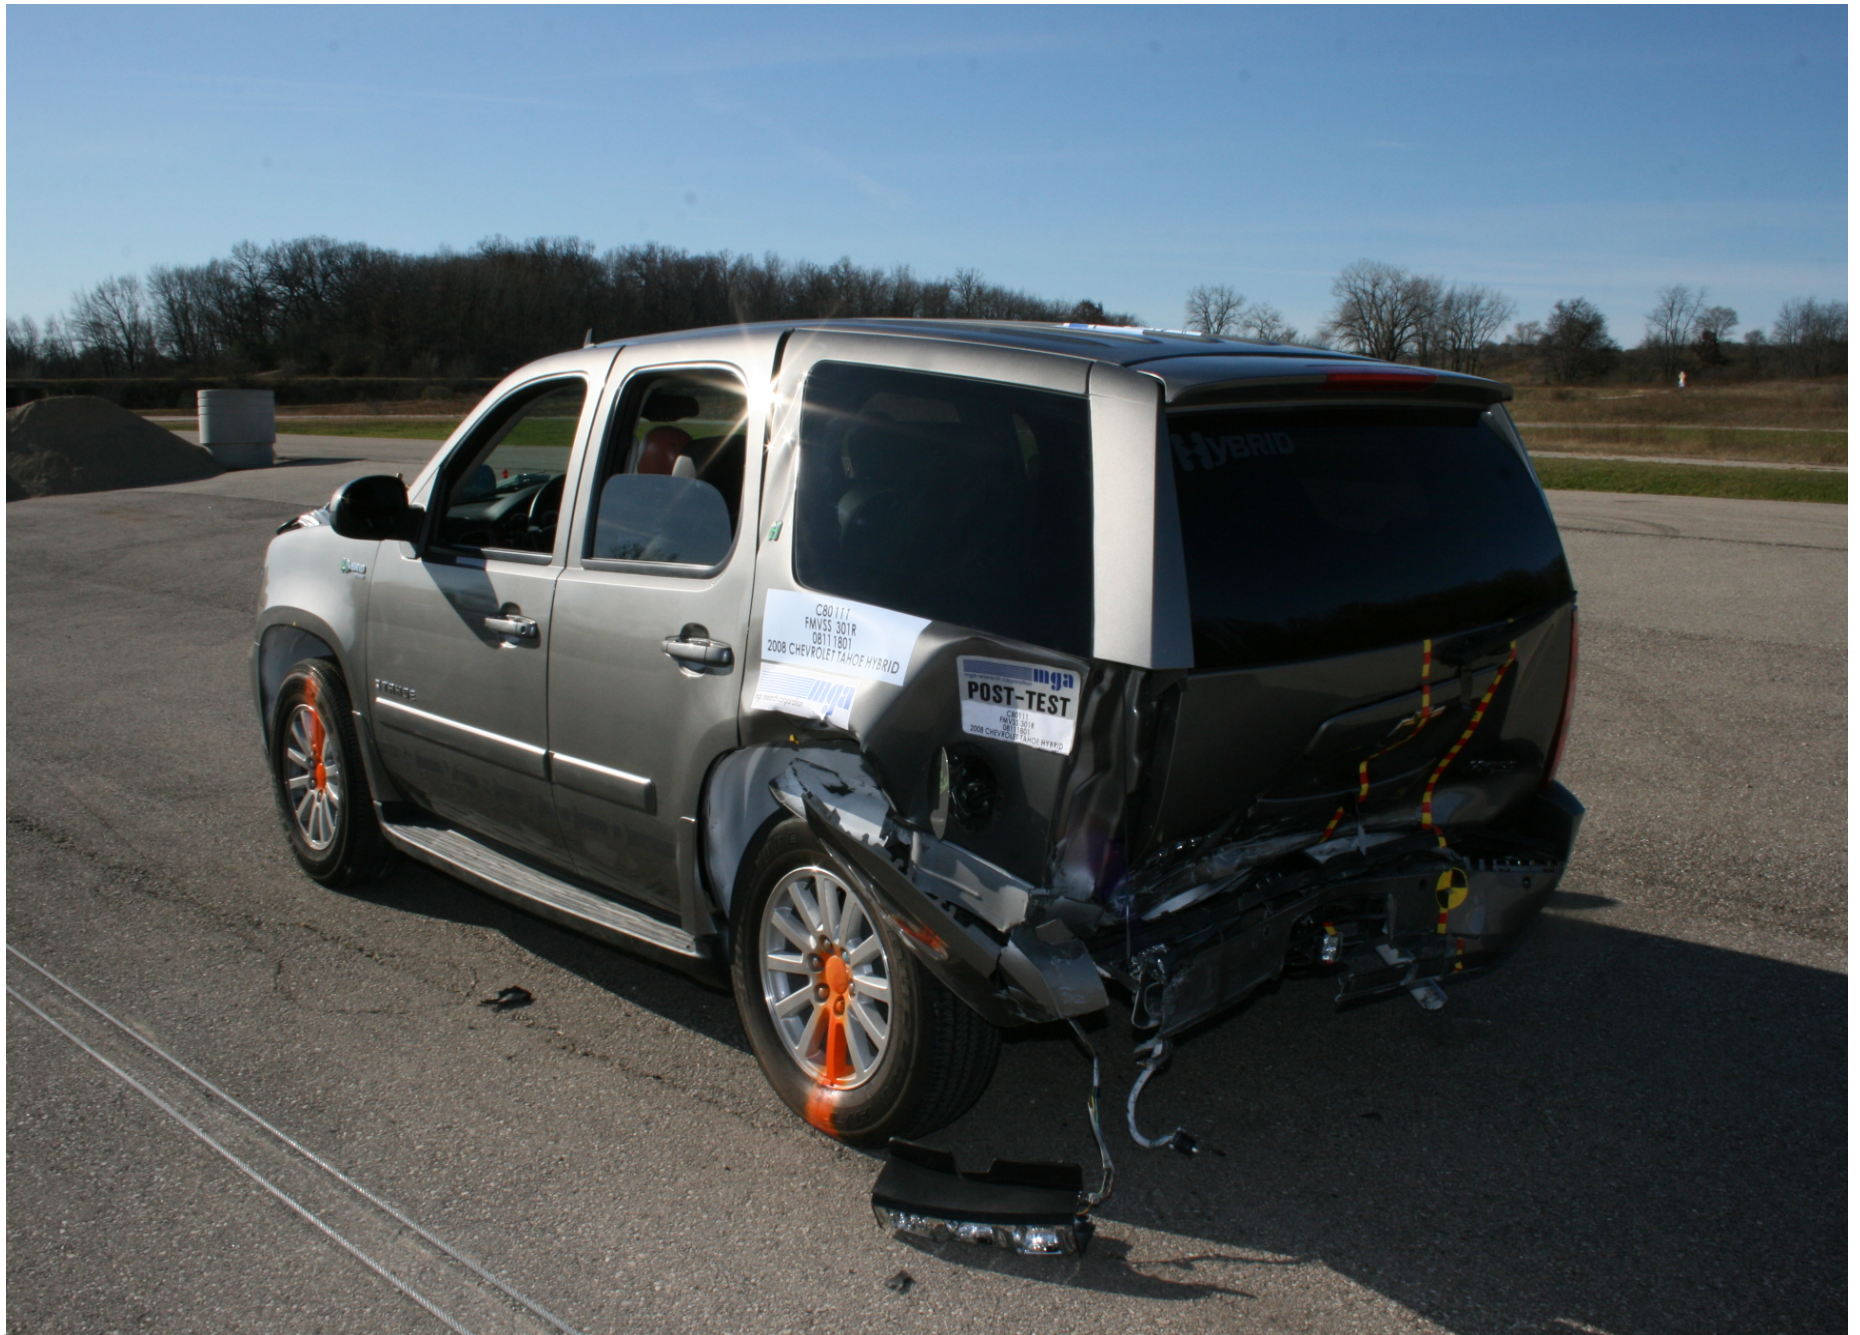
Post-Test ¾ Rear View From Left Side of Vehicle

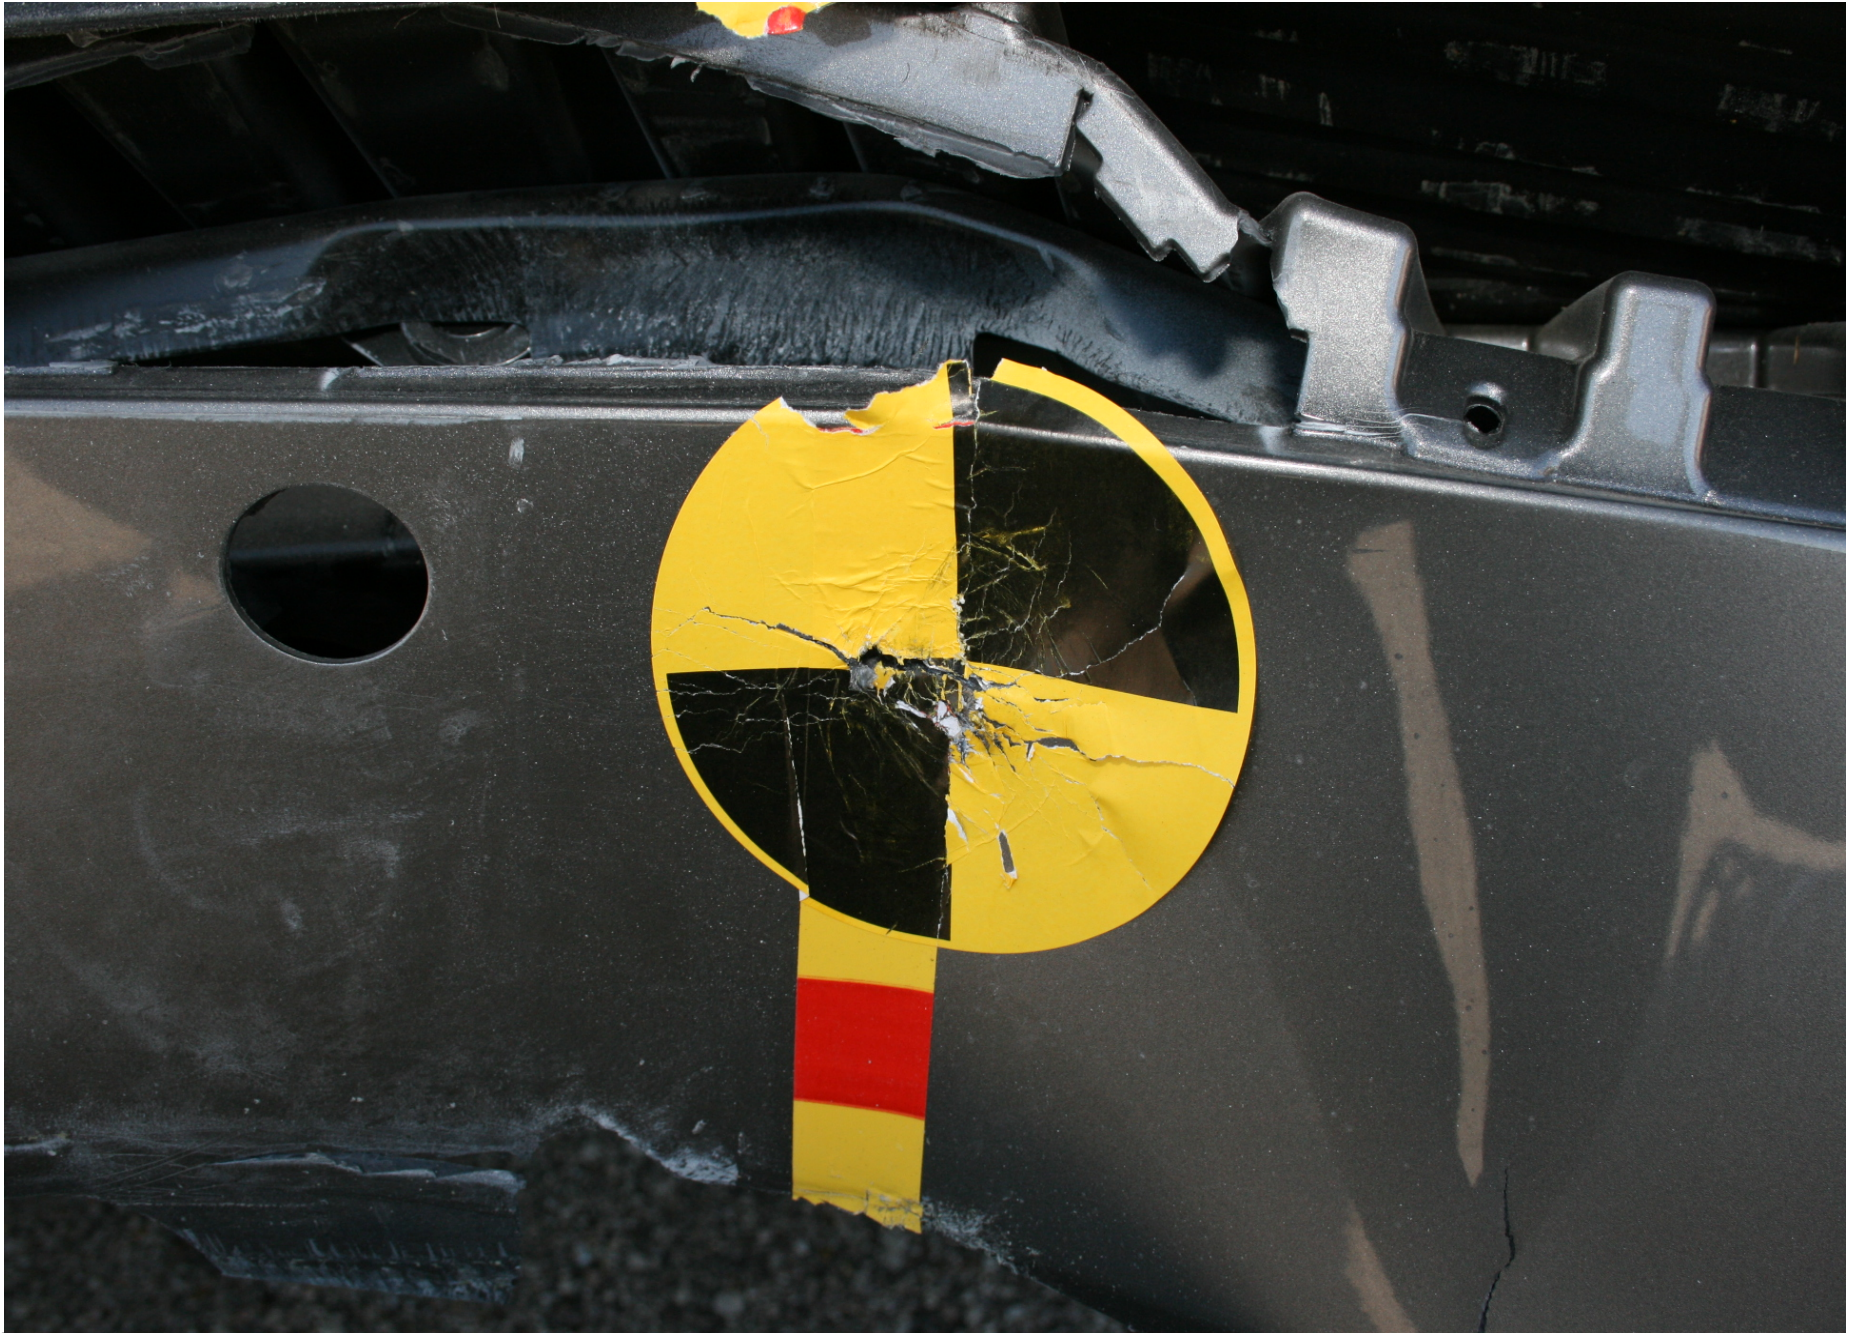
Post-Test Impact Point

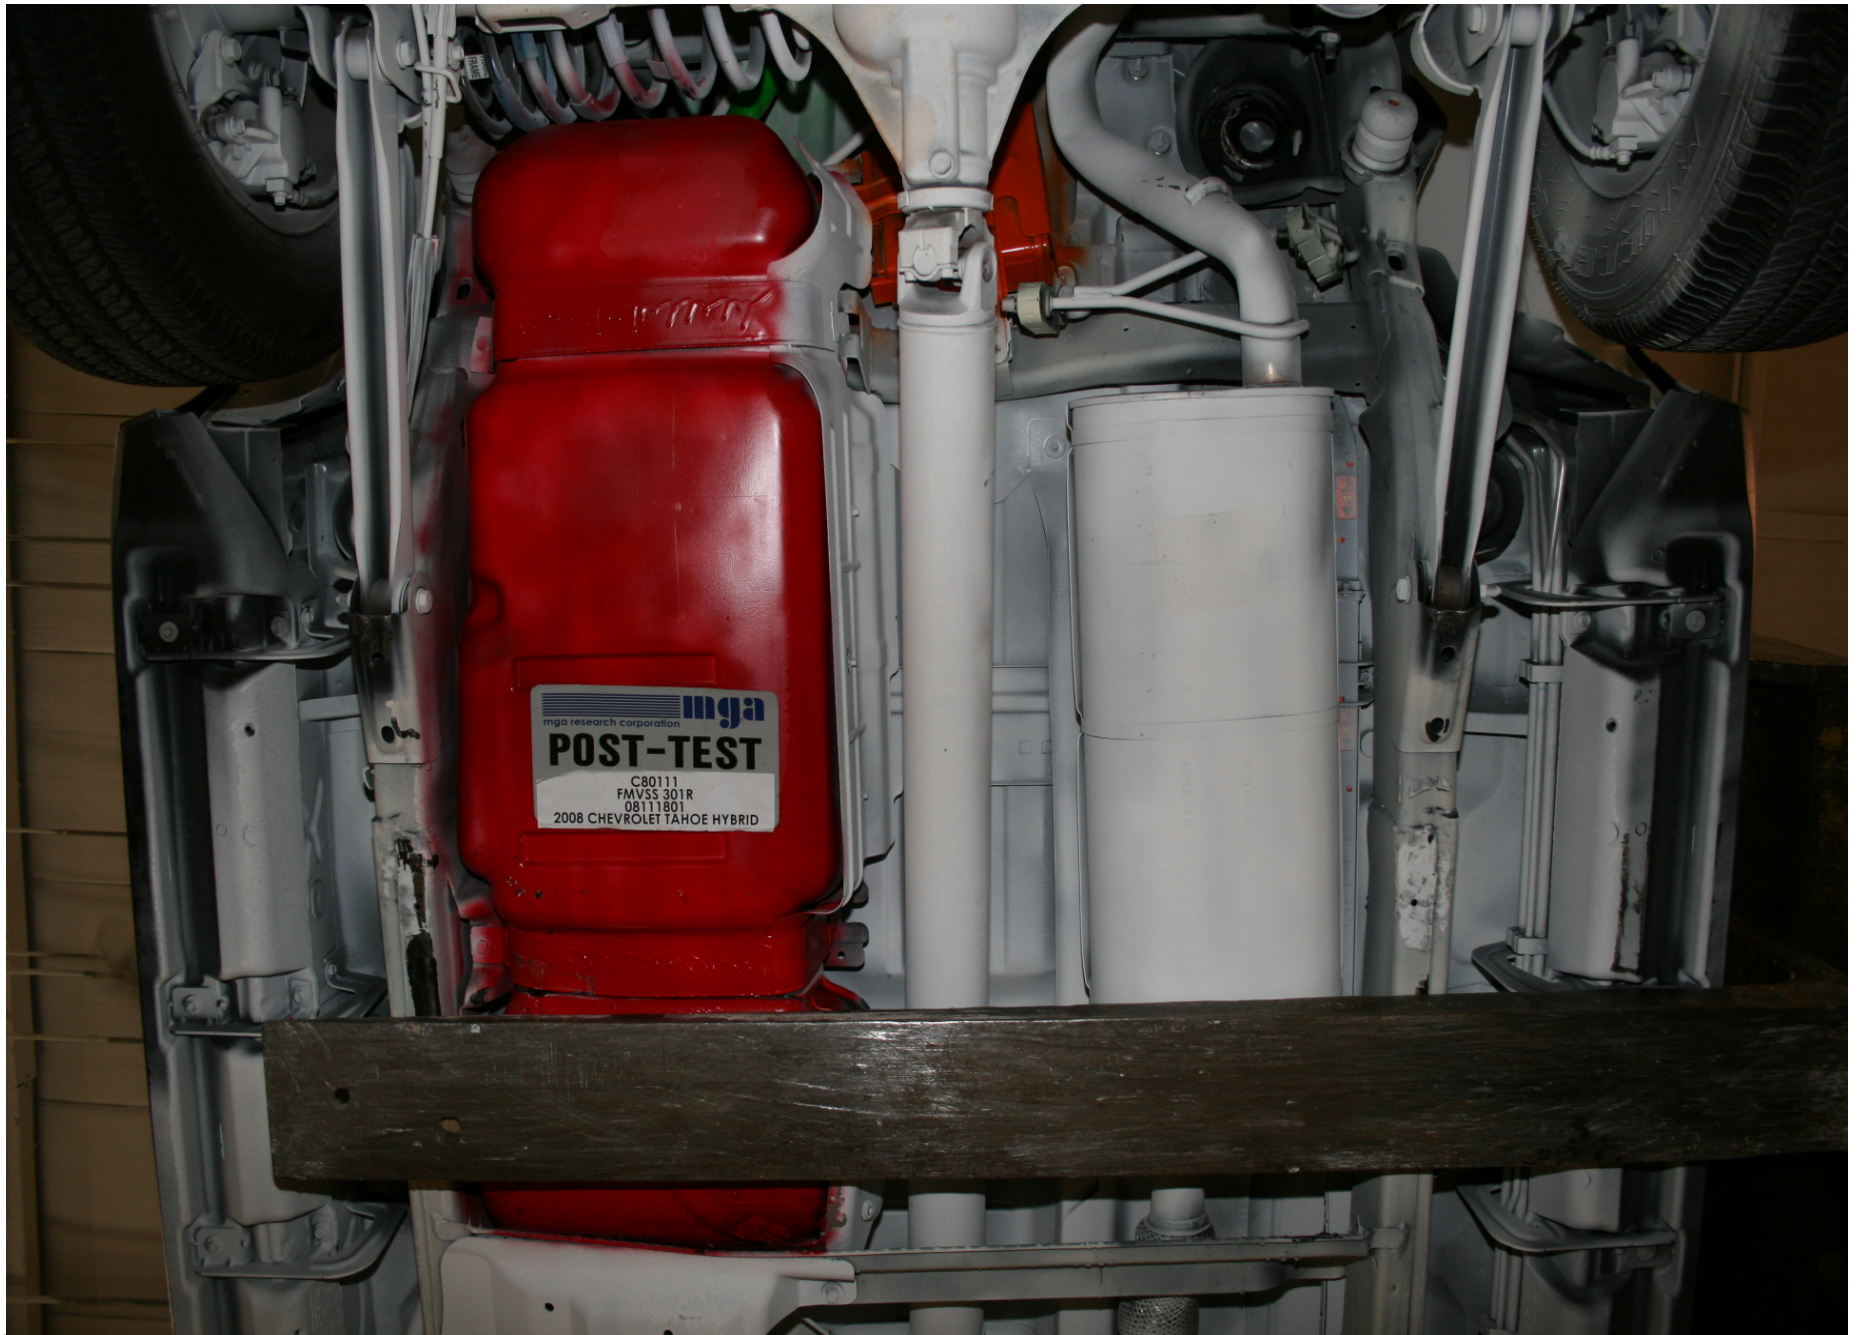
Post-Test Underbody View 2
